# Overcladding:

## When Masonry Repairs Just Don't Make Sense

By Ian Miller, PEng., LEED AP, Pretium Anderson Waterloo Inc. & Louis Reginato, B.Tech., PEng., Pretium Anderson Waterloo Inc.

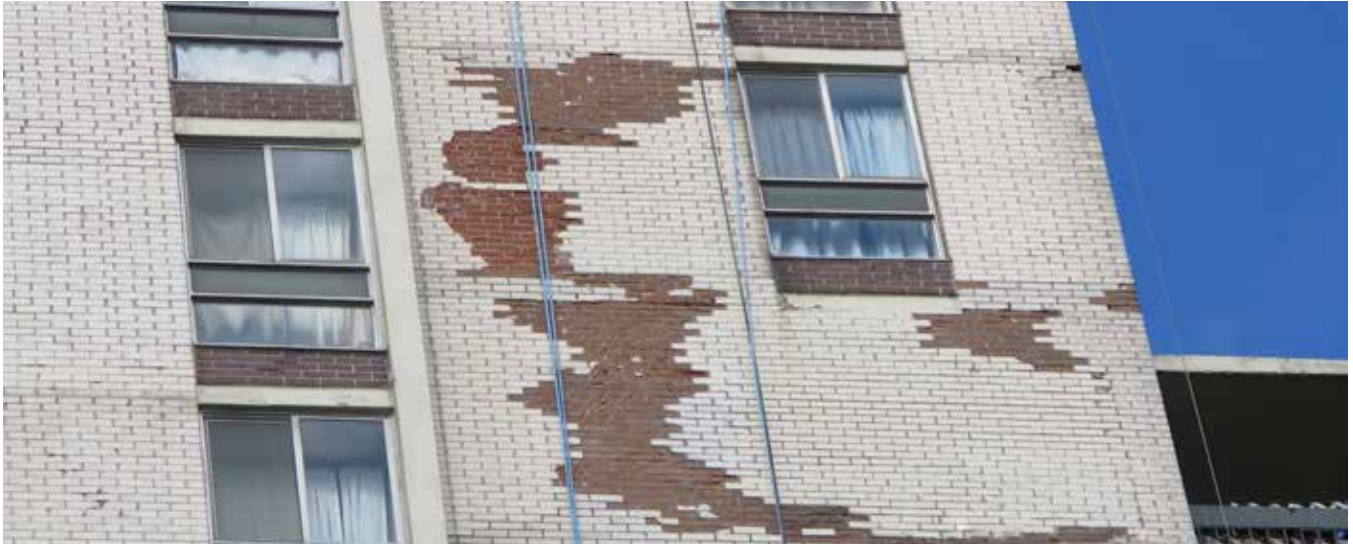
*An example of highly deteriorated glazed brick.*

Similar issues with brick availability and deterioration present themselves for buildings constructed with glazed brick. Using glazed brick gained popularity in the 1970s. New brick styles were made possible by adding a ceramic glaze to the exterior face of the masonry. This often took the form of a glossy white (or other colour) glaze.

This brick was used on many buildings, but it has issues in cold climates; water penetrating into the brickwork through the mortar is absorbed by the brick. Because of the ceramic glaze, which creates low permeability at the brick face, the moisture cannot dry out as easily. Freeze/thaw cycles then result in delamination and spalling of the brick faces, which weakens the brick and creates an unsightly mar on the building exterior.

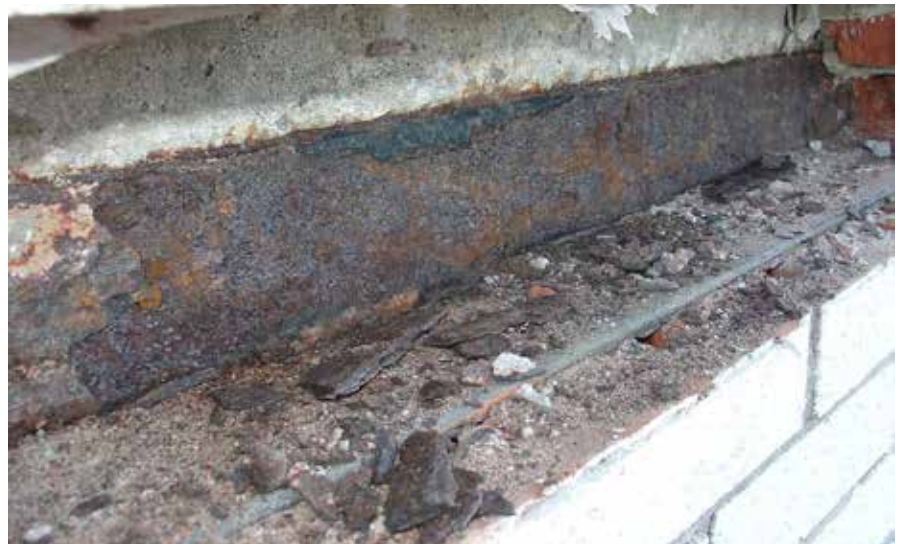
*A steel shelf angle exhibiting moisture-related deterioration, resulting in a reduction in load-bearing capacity.*

With brick that is supported by steel angles, through-wall flashings were not often installed, were poorly installed, or have deteriorated to the point that they are no longer effective. This exposes the steel shelf angles to water, creating ideal conditions for corrosion. As the shelf angles corrode, their strength decreases,

sometimes to the point of becoming a structural concern.

Expansion due to corrosion also results in brick deterioration, and in some cases, bowing and failure of the brickwork. The steel ties that restrain the brick to the concrete block back-up wall are also exposed to water and

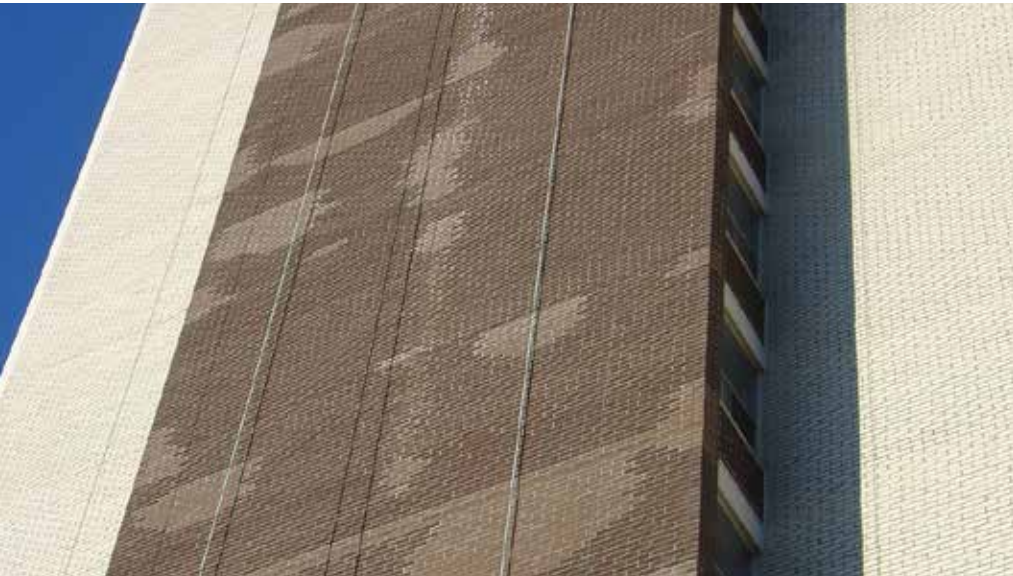
*A brick veneer wall exhibiting repairs completed over many years.*

The common thread among these brick masonry wall systems is that effective, long-term repairs are difficult to achieve. Typical repairs consist of partial brick replacement, mortar joint repointing, application of sealant at cracks, and/or the application of coatings to seal cracks and minimize water absorption.
